PRELIMINARY ASSESSMENT

Columbus Auto Parts**DATE:** 15, May 1994**OHIO ID #:** 125-1461**USEPA #:** OHD004286381

Address: 575 Hudson Street
Columbus, Ohio 43216
Franklin County

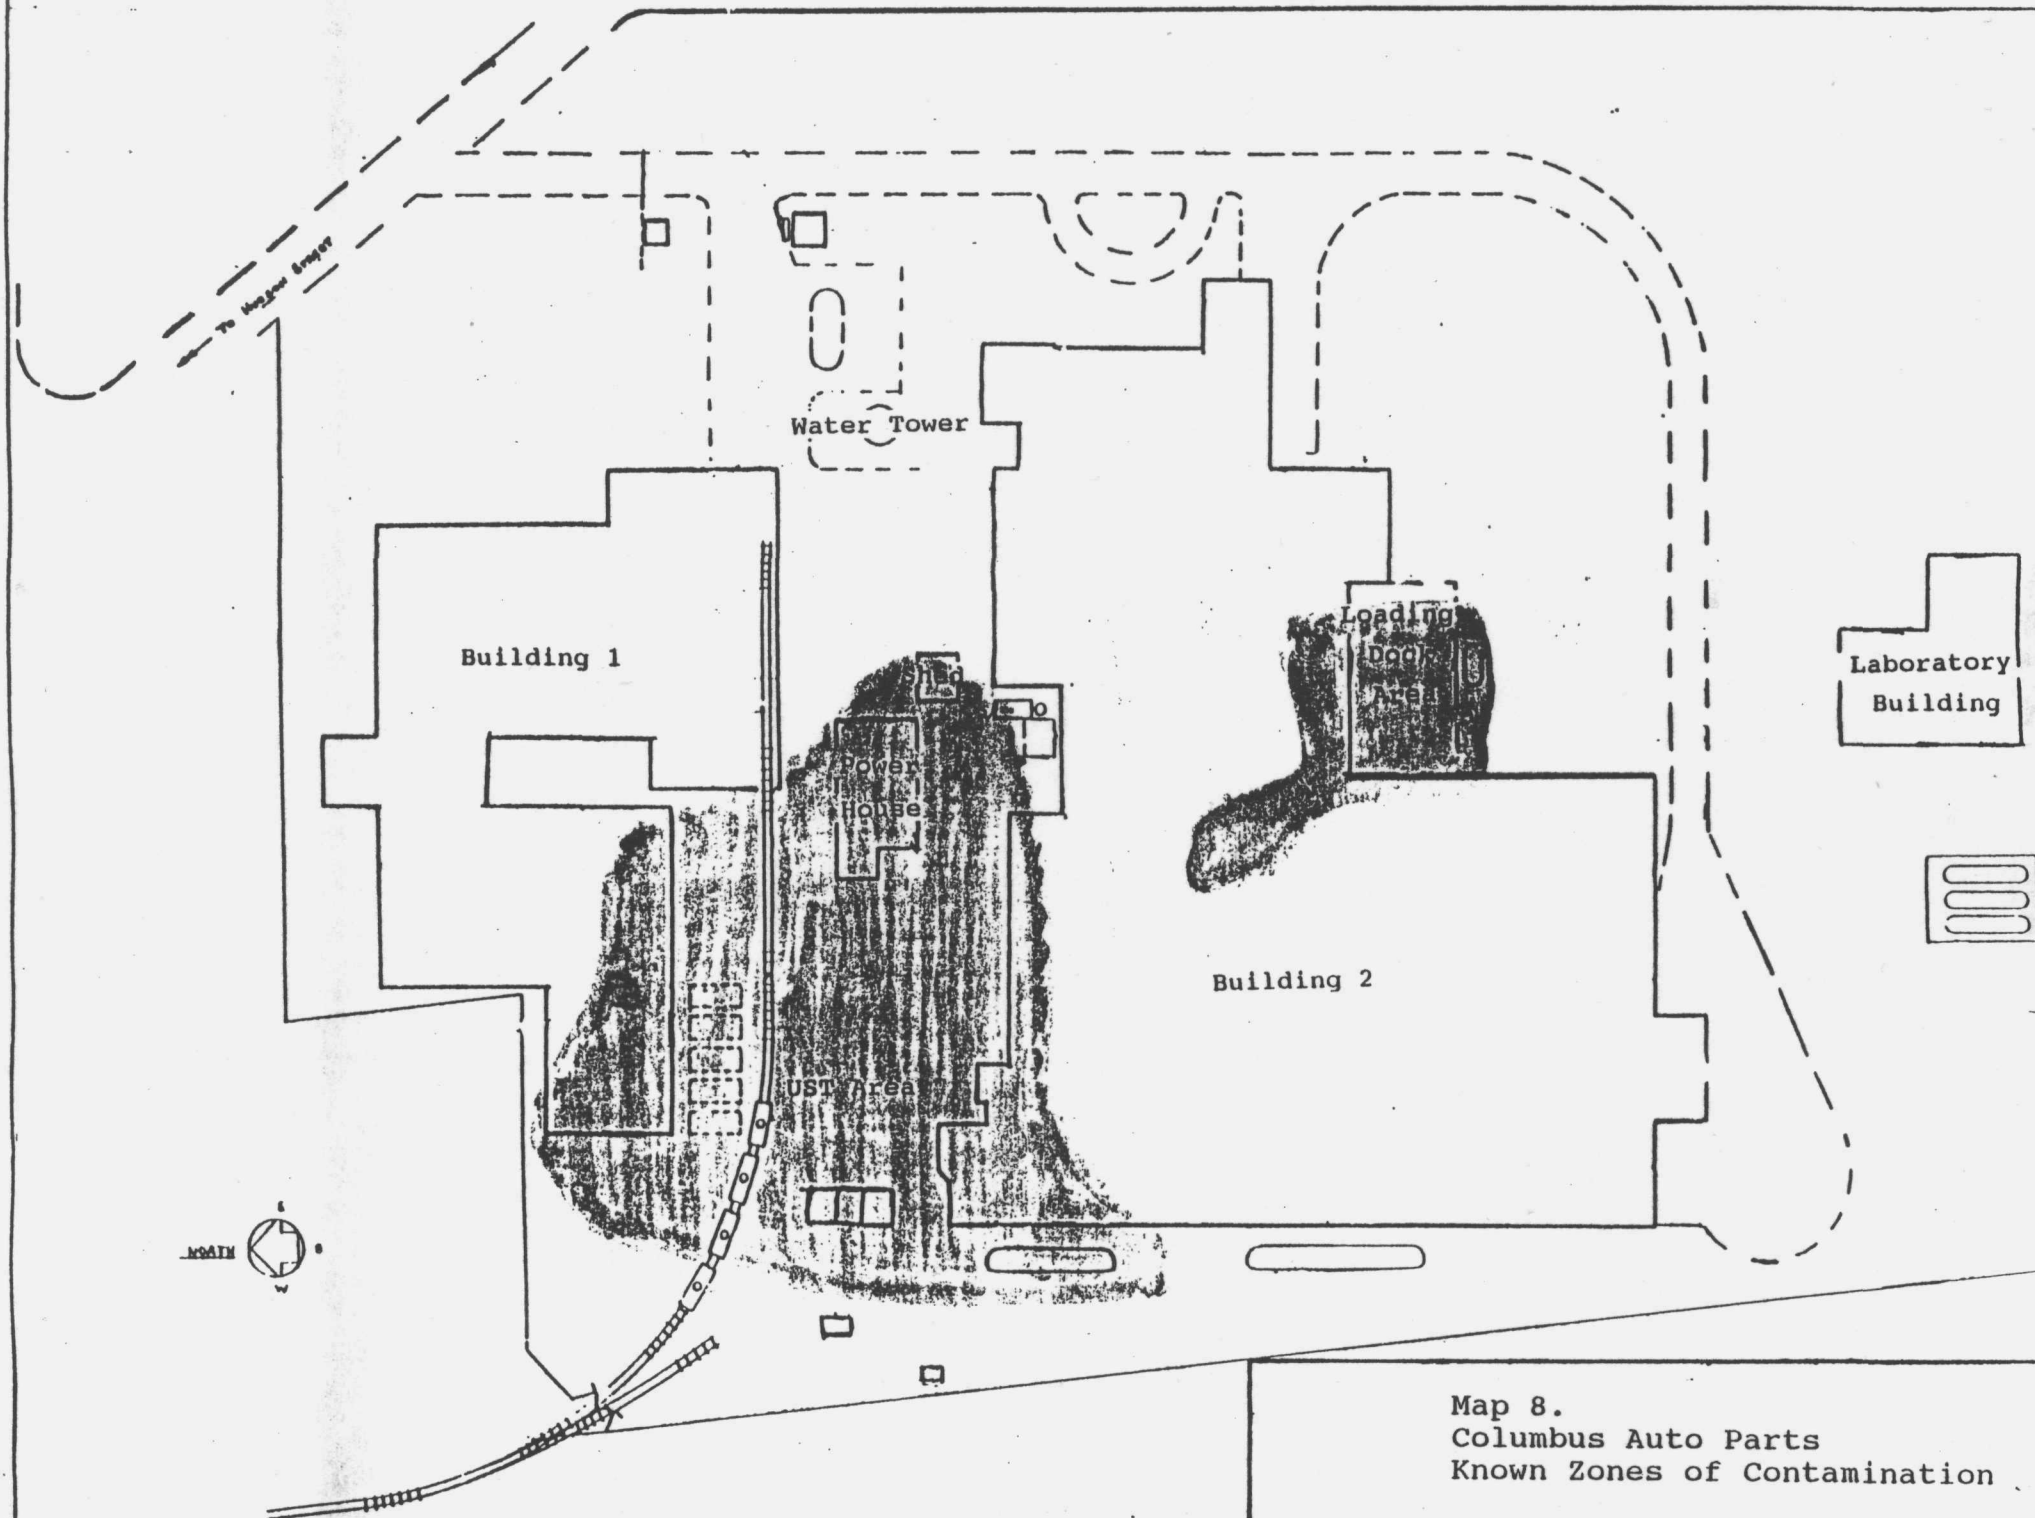
Map 8.
Columbus Auto Parts
Known Zones of Contamination

As a result of the Assessment, three principal areas of oil, volatile organic compound (VOC) and polynuclear aromatic hydrocarbon (PAH) contamination were determined: the Oil Pit area, the Loading Dock and the areas between and to the west of Buildings 1 and 2 (including the Shed and underground storage tank (UST) area). All of the facility's buildings contained asbestos. VOC, PAH and oil contamination was found in the soil throughout the areas demarcated on Map 8. The only identified source of polychlorinated biphenyl (PCB) contamination was found in the structure known as the Shed. The sample collected from the Shed yielded 180 ppm of PCBs, but no VOCs or SVOCs were tested for at that site.
